# ANNUAL REPORT FOR 2014

**Bald Creek Site #4 Mitigation Site**  
**Yancey County**  
**TIP No. R-2518B**  
**COE Action ID: SAW-2007-2197-357/300**  
**DWR #: 20071134**

Prepared By:  
Natural Environment Section & Roadside Environmental Unit  
North Carolina Department of Transportation  
December 2014

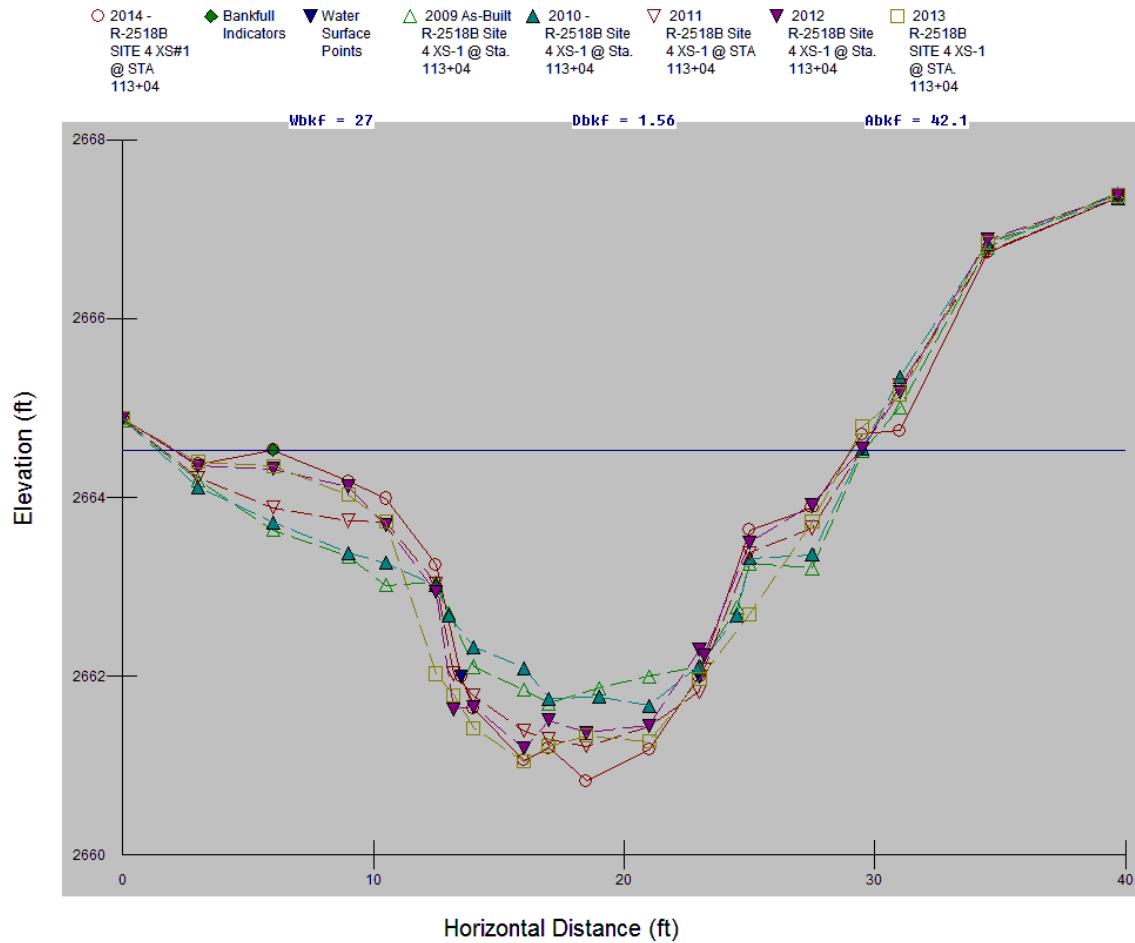
# R-2518B SITE 4 XS#1 @ STA 113+04

Based on comparisons of the As-Built data to monitoring data, all of the cross sections appear stable with little or no active bank erosion. Graphs of the cross sections are presented in Appendix A. Future survey data will vary depending on actual location of rod placement and alignment; however, this information should remain similar in appearance.

Site #4: Cross-Section #1 (Pool) Abbreviated Morphological Summary*					
	2010	2011	2012	2013	2014
Bankfull Cross Sectional Area (ft <sup>2</sup> )	54.78	56.12	52.46	57.19	41.83
Maximum Bankfull Depth (ft.)	3.22	3.67	3.7	3.84	3.7
Bankfull Mean Depth (ft.)	1.82	1.86	1.73	1.91	1.81
Bankfull Width (ft.)	30.14	30.23	30.31	29.92	23.06

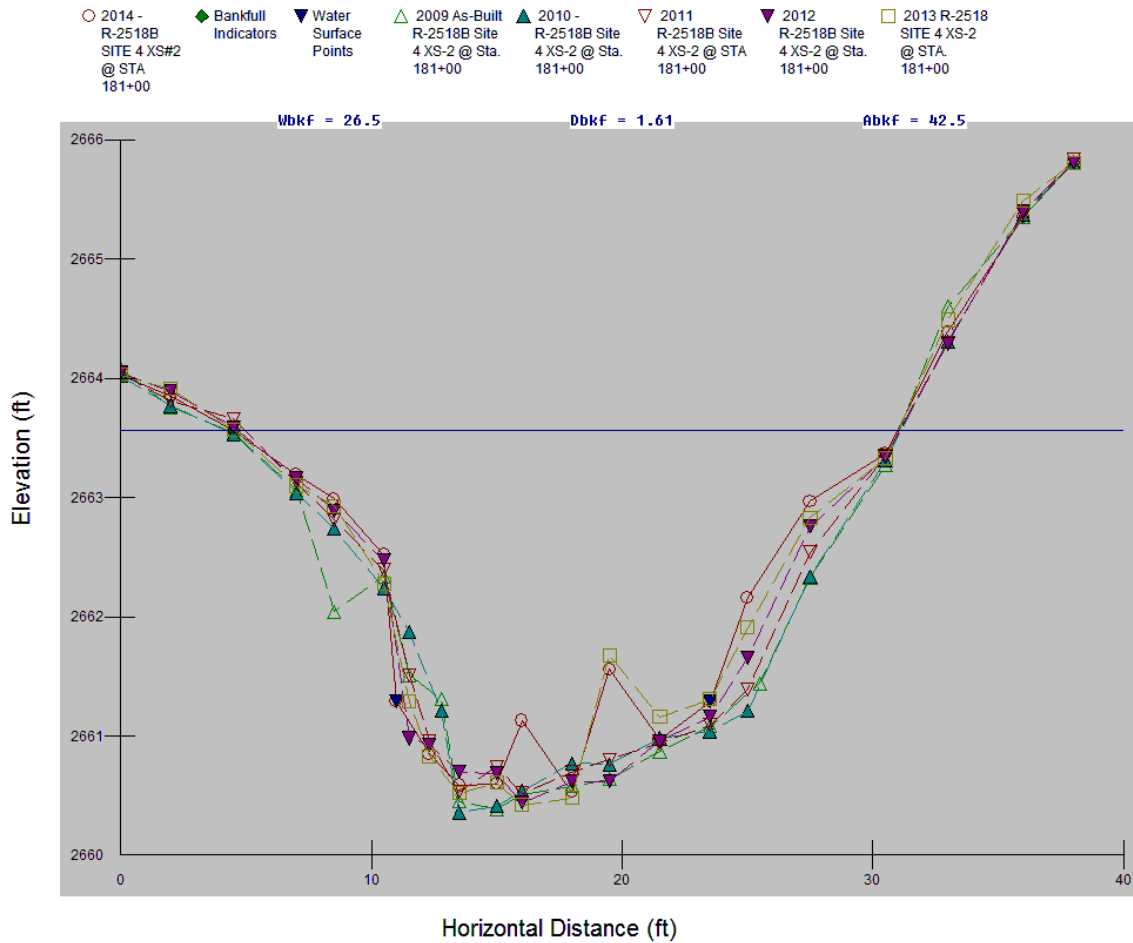
## R-2518B SITE 4 XS#2 @ STA 181+00

Site #4: Cross-Section #2 (Riffle) Abbreviated Morphological Summary					
	2010	2011	2012	2013	2014
Bankfull Cross Sectional Area (ft <sup>2</sup> )	47.84	50.03	47.53	44.6	42.53
Maximum Bankfull Depth (ft.)	3.17	3.14	3.15	3.15	3.03
Width of the Floodprone Area (ft.)	38	38	38	36	38
Bankfull Mean Depth (ft.)	1.8	1.87	1.78	1.68	1.61
Width/Depth Ratio	14.75	14.34	14.98	15.79	16.44
Entrenchment Ratio	1.43	1.42	1.43	1.36	1.44
Bankfull Width (ft.)	26.55	26.82	26.66	26.52	26.47

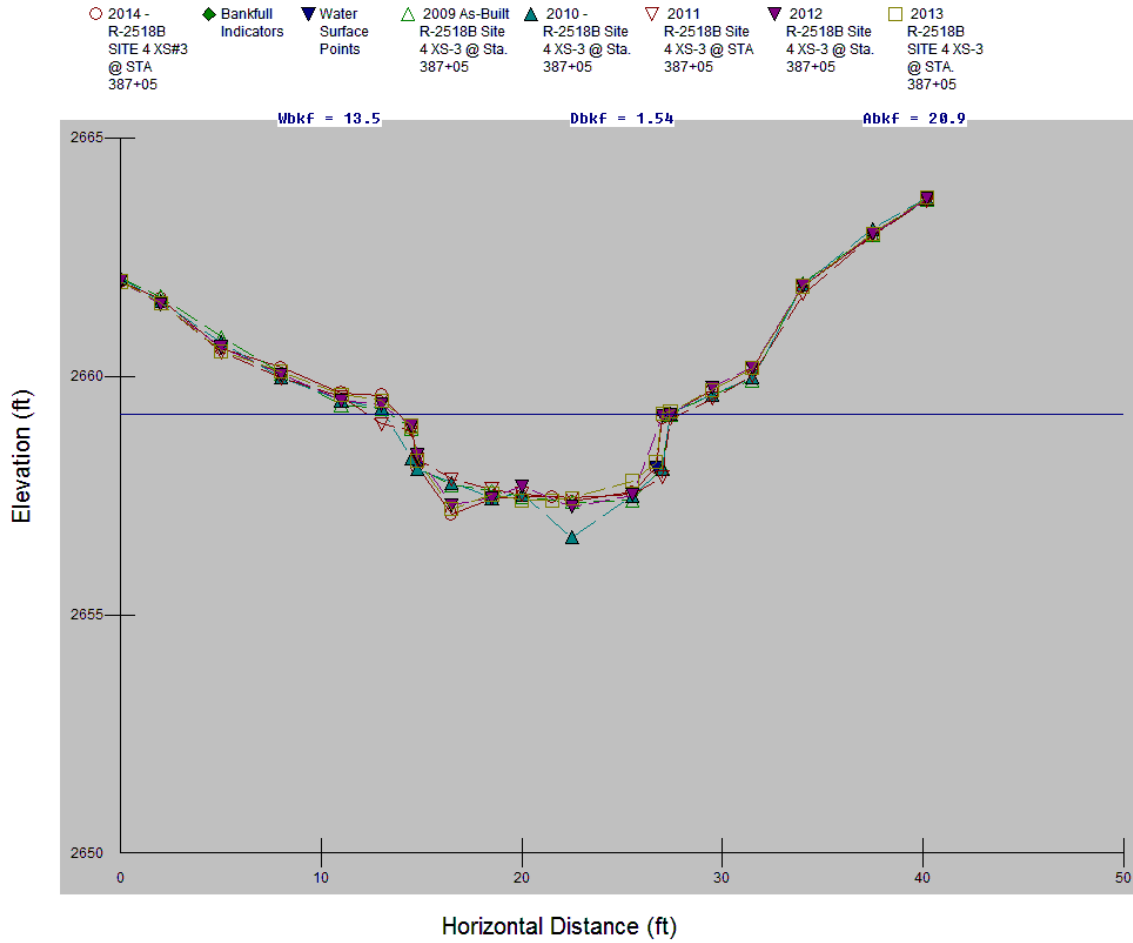
# R-2518B SITE 4 XS#3 @ STA 387+05

Site #4: Cross-Section #3 (Riffle) Abbreviated Morphological Summary					
	2010	2011	2012	2013	2014
Bankfull Cross Sectional Area (ft <sup>2</sup> )	23.26	18.56	19.61	20.6	20.88
Maximum Bankfull Depth (ft.)	2.6	1.66	1.93	2.04	2.09
Width of the Floodprone Area (ft.)	32.87	28.38	29.56	30.43	30.17
Bankfull Mean Depth (ft.)	1.63	1.26	1.43	1.5	1.54
Width/Depth Ratio	8.73	11.74	9.57	9.17	8.79
Entrenchment Ratio	2.31	1.92	2.16	2.21	2.23
Bankfull Width (ft.)	14.23	14.79	13.68	13.75	13.53

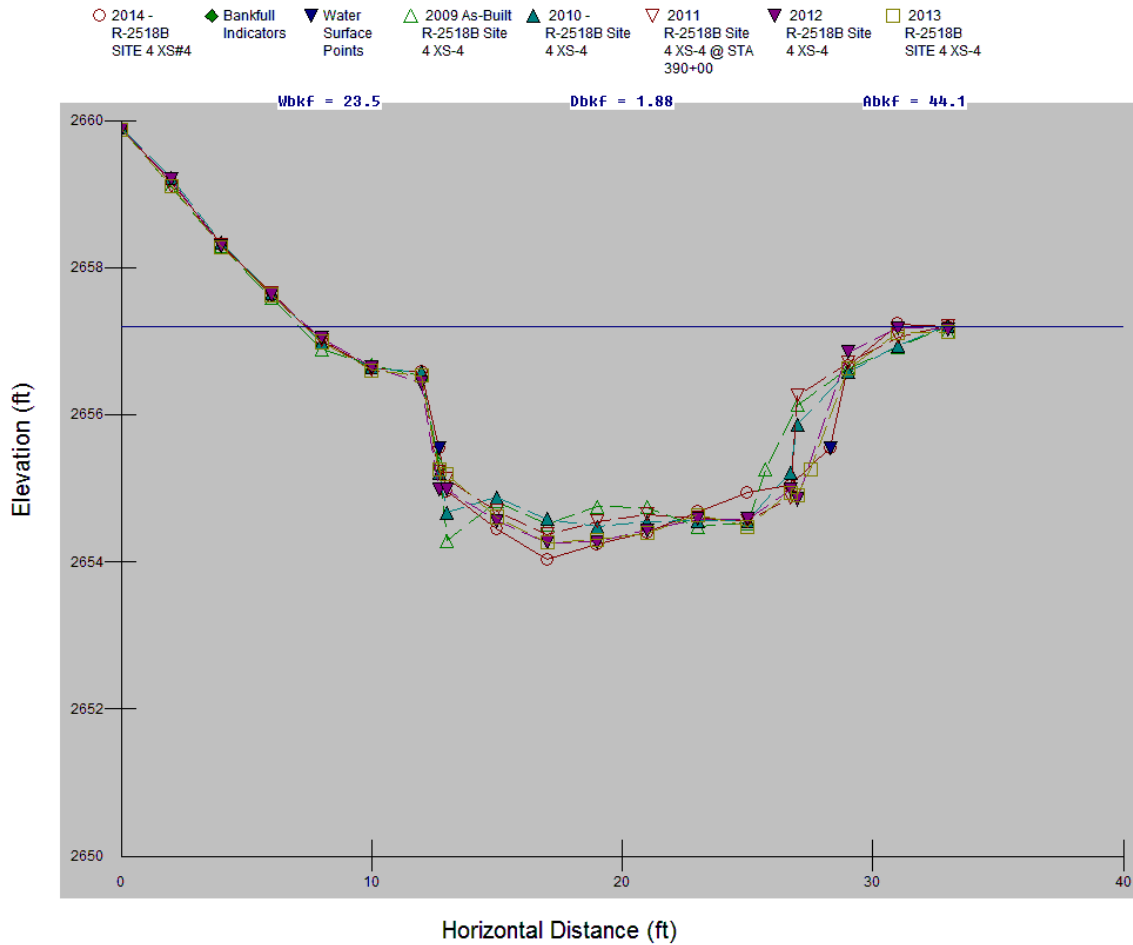
# R-2518B SITE 4 XS#4

Site #4: Cross-Section #4 (Pool) Abbreviated Morphological Summary*					
	2010	2011	2012	2013	2014
Bankfull Cross Sectional Area (ft <sup>2</sup> )	42.48	41.78	43.36	42.64	44.12
Maximum Bankfull Depth (ft.)	2.73	2.84	2.9	2.86	3.16
Bankfull Mean Depth (ft.)	1.65	1.63	1.86	1.68	1.88
Bankfull Width (ft.)	25.69	25.6	23.29	25.41	23.46

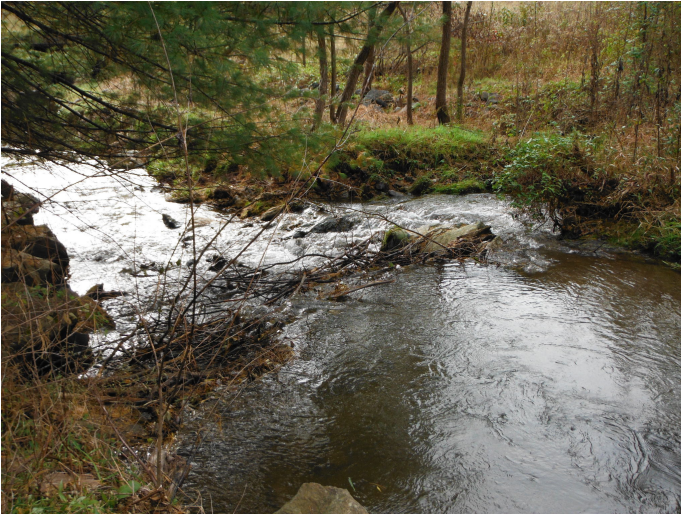
Beaver dam downstream of Cross Section #4  
November 2014

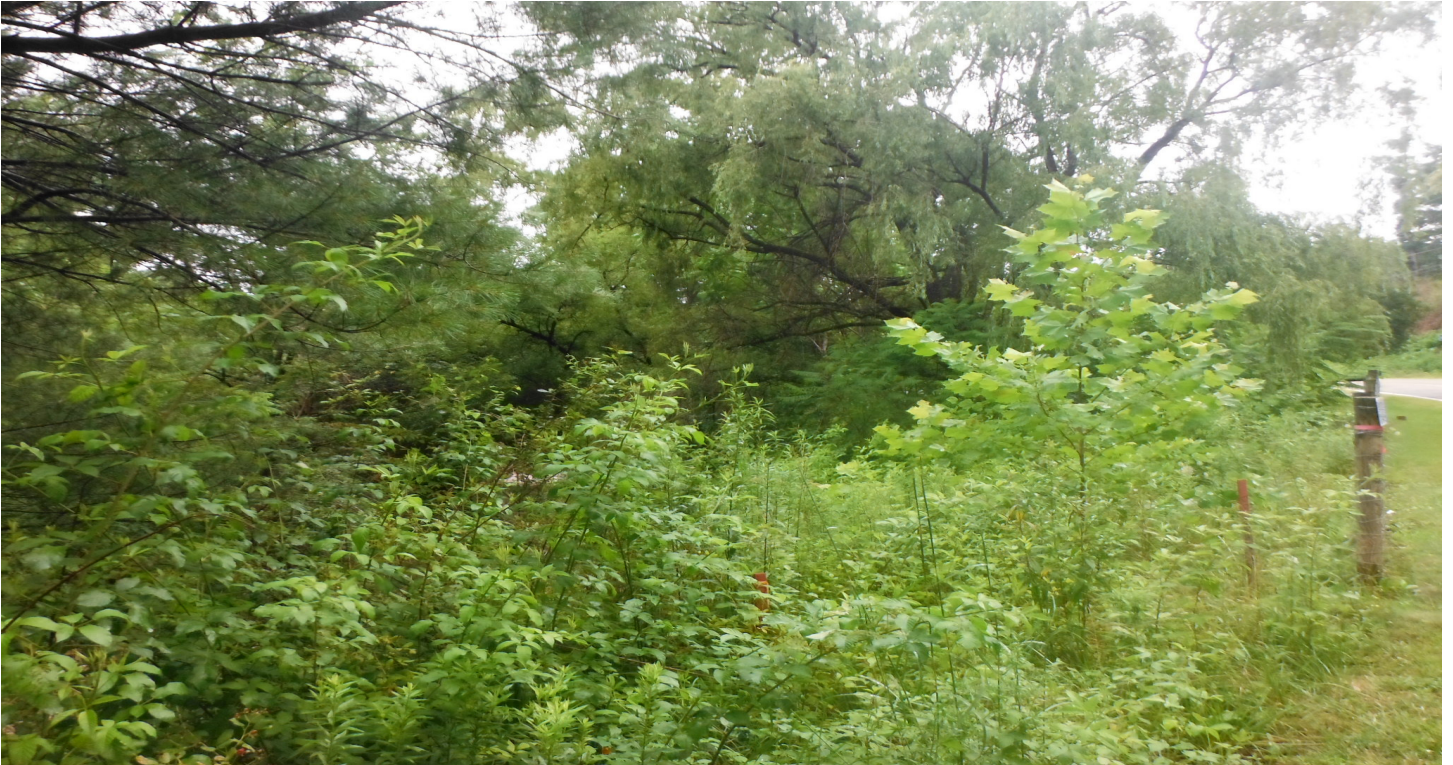
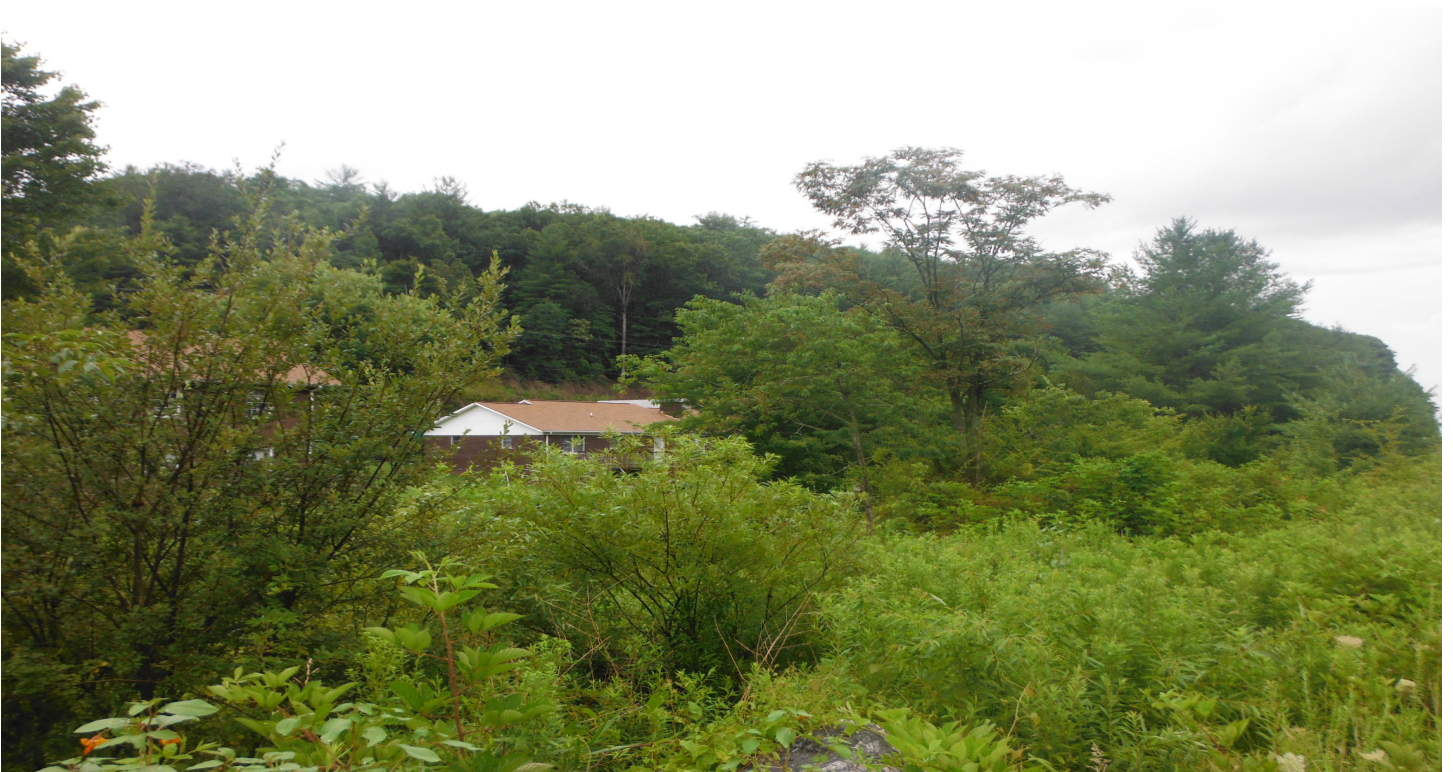
Vegetation Overview Photo

**Streambank & Buffer Vegetation:** The streambank reforestation was completed in March 2012. The Year 3 vegetation monitoring evaluation noted: Type I: Black Willow, Silky Dogwood and Type II: Sycamore, Green Ash, Tulip Poplar, and White Oak were surviving at the time of the monitoring evaluation.
